INVESTIGATION

Bryson Crash

INVESTIGATION OF THE BRYSON CRASH

EXPERT'S SUPPLEMENTAL REPORT

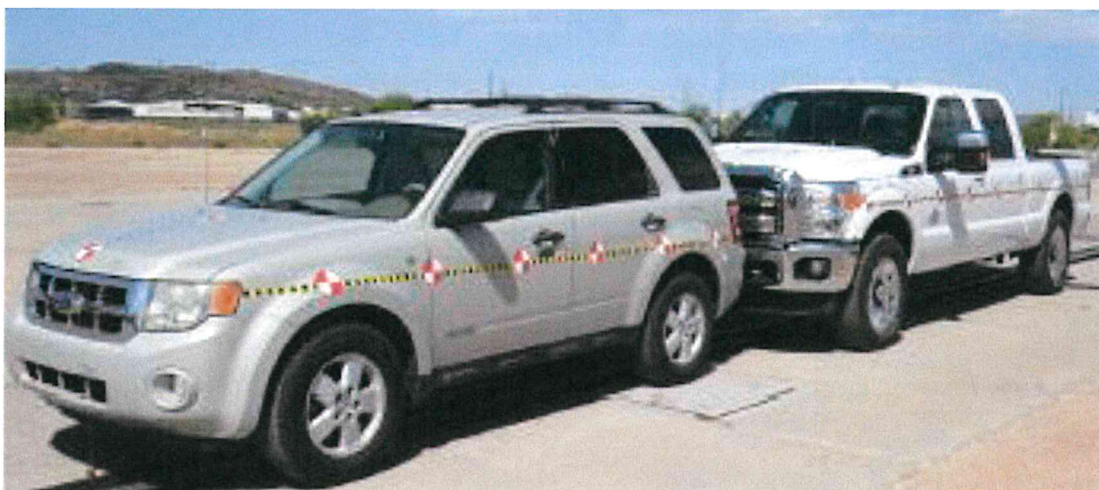
Image 1: Pre-Test Vehicle Condition

Both vehicles were ballasted, instrumented and the impact velocity of the F-250 was reported as 49.9mph with the test set up so that the front of the F-250 struck the rear of the Escape. The Escape was positioned to the right of the F-250 (and the test guide rail centerline) with an offset of about 10.8". To date, there has been no opportunity to inspect the tested vehicles. Image 1 shows the pre-test impact configuration.

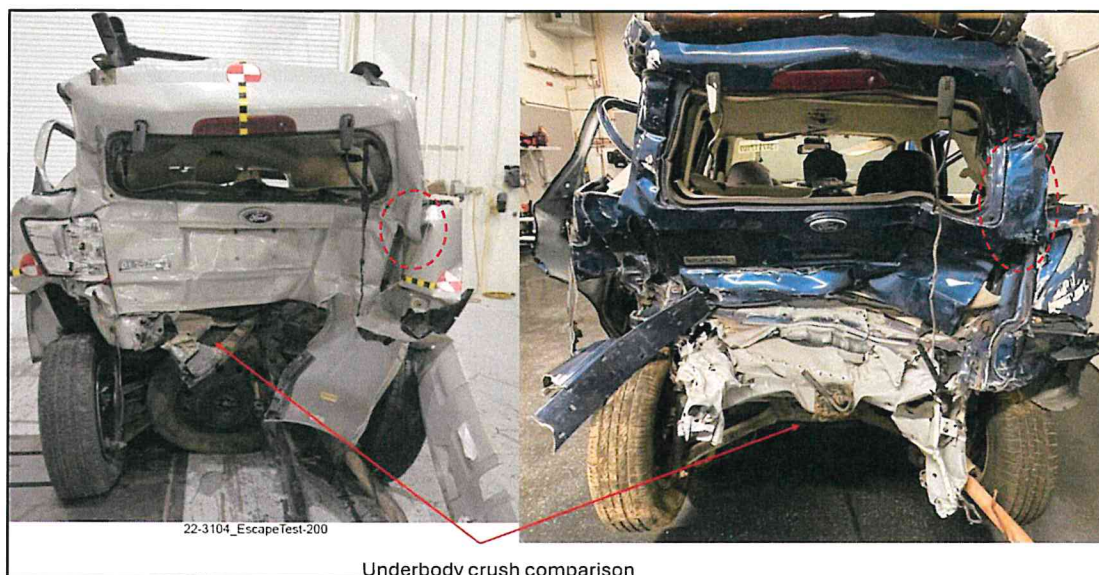
Image 2: Deformed Escape Comparison – Rear View

12. The tested Escape exhibited significantly increased underbody deformation than the subject Escape – Image 2 shows a comparison of the two vehicles, with the tested Escape on the left and the subject vehicle on the right. The tested Escape's underbody has been deformed, the rear rails are not exposed, and the rear floor is not visible. There was vertical alignment of the vehicle energy absorbing structures in the test.

13. The lateral vehicle overlap in the test does not match the subject condition. Image 2 shows that the right side of the subject liftgate pillar exhibits direct contact deformation (circled), whereas the tested Escape exhibits induced damage, or non-direct deformation. This indicates that the alignment of the vehicles was further offset in the test than the subject crash, resulting in less lateral overlap and therefore less structural engagement in the crash test.

Additionally, the crash test overlap and setup are unrepresentative of the subject crash. The overlap between the two vehicles was additionally offset by at least 4” based on the deformation pattern of the liftgate and the width of this structure, resulting in less lateral engagement in the crash test than the subject test. Less lateral engagement results in the impact being concentrated on a smaller area of the Escape. It is possible that the guidance system used for the F-250 was unable to maintain the test setup

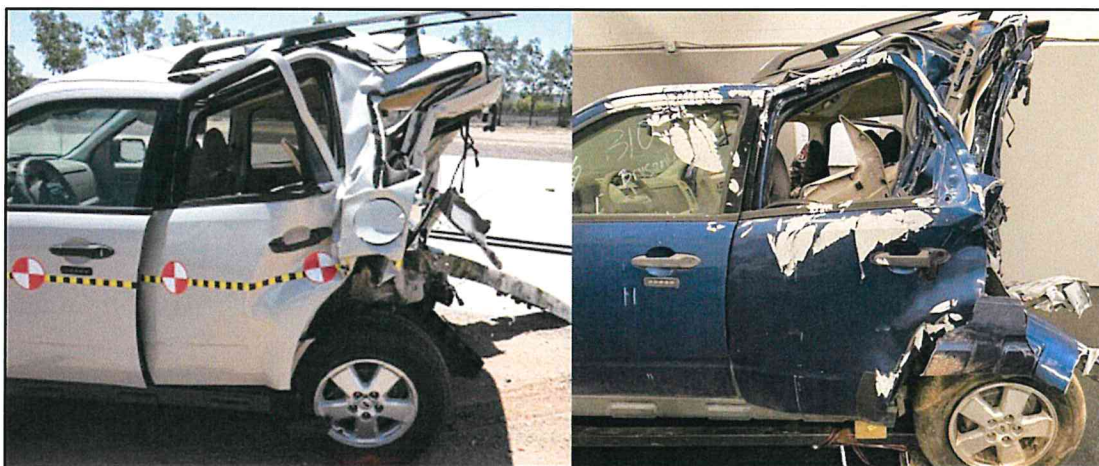
Image 3: Deformed Escape Comparison – Left Side View

14. The tested Escape exhibited less deformation on the left bodyside rearward of the rear door than the subject Escape – Image 3 shows a comparison of the two vehicles, with the tested Escape on the left and the subject vehicle on the right. The tested Escape's C pillar is still visible, and the fuel filler door undeformed whereas the subject Escape's C pillar has been deformed forward of the rear door's trailing edge. The crash tested Escape's roof is also less crushed.

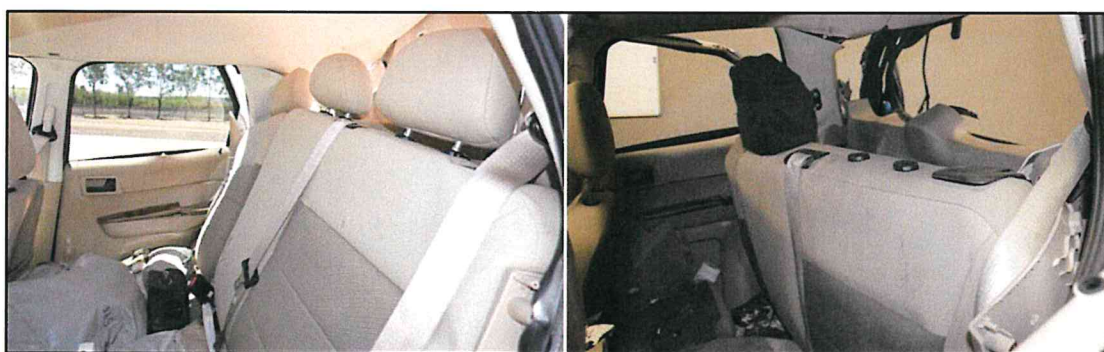
Image 5: Rear Seat Comparison

16. The tested Escape exhibited less rear seat static deformation (forward in vehicle) than the subject Escape – Image 5 shows a comparison of the two vehicles, with the tested Escape on the left and the subject vehicle on the right. The seat back angle is still rearward in the tested Escape, with the headrests adjacent to the C pillar. Whereas the subject Escape's seat back angle is forward, with the headrests significantly forward of the C pillar.

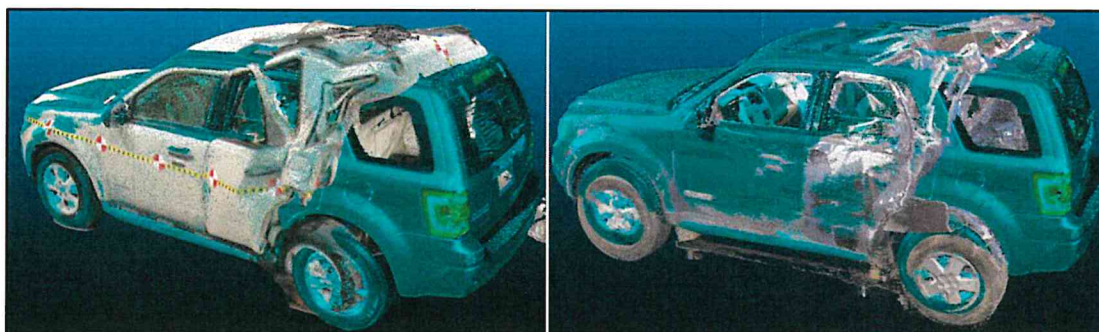
Image 6: Point Cloud Overlays

17. An analysis of overlaid laser scan point cloud data for an exemplar Escape with both the crash test Escape and the subject Escape (Image 6 – crash test on left, subject on right) identifies the following:
- a. The subject Escape's wheelbase (left side) was almost unchanged at 103".
 - b. The crash test Escape's wheelbase (left side) was reduced by about 5".
 - c. The subject Escape's static seat back angle changed from about 65° to the horizontal to greater than 90°, being rotated forward. See Image 7 with the subject Escape on the right.
 - d. The crash test Escape's static seat back angle (post-test) was largely unchanged from the pre-test condition. See Image 7 with the crash test Escape on the left.

Grimes did not conduct a detailed analysis of the structural intrusions or the rear seat static movement between the crash test and subject crash. His only intrusion analysis consisted of an overlay of the point cloud data of the two sets of vehicles, and he opined that the crash test intrusion was higher than the subject crash intrusion. He did not study the intrusion related to the second-row survival space. If the crash test intrusions were higher than the subject crash, this would be unusual and contrary to known compatibility testing data and published reports. In Ford's compatibility research (Roche 1st supplemental report) the intrusions were increased with the truck's ride height being increased. In NHTSA's compatibility testing¹ there was a reduction of intrusion by about 5" when a 2006 Ford F-250s with a Blocker beam (SEAS) was crashed into 2002 Ford Focus compared to a F-250 without a Blocker beam. The addition of the SEAS resulted in more structural compatibility and reduced the intrusion in the struck vehicle. The Exponent crash test intrusion increase is likely due to the test setup, including the vehicle ballasting, vehicle overlap and possible park brake engagement of the Escape.

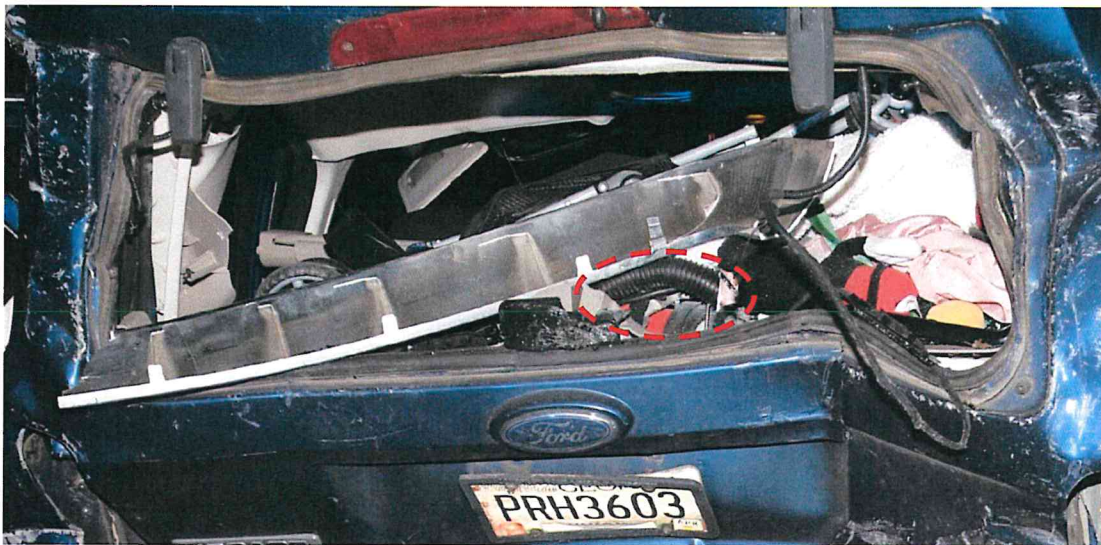
Image 11: Crash Scene Image of the subject Escape

The cargo in the subject Escape consisted of a shop-vac, an umbrella stroller, two camping chairs and a bag of clothing (per Plaintiff's responses to RC's second interrogatories). From the images available from

the scene and subsequent inspection (Images 11 and 12) the shop-vac location is on the right side of the luggage compartment. Additionally, the shop-vac canister was significantly crushed during the crash – Image 13. Despite this information, no attempt was made to add the cargo to the crash test to determine the influence, if any, of the cargo on the vehicle intrusions. Grimes' claims that:
